US Army Corps
of Engineers
Baltimore District

ENVIRONMENTAL HEALTH FACILITY ASSESSMENT

Ft. Myer Building 248

Joint Base Myer-Henderson Hall, VA

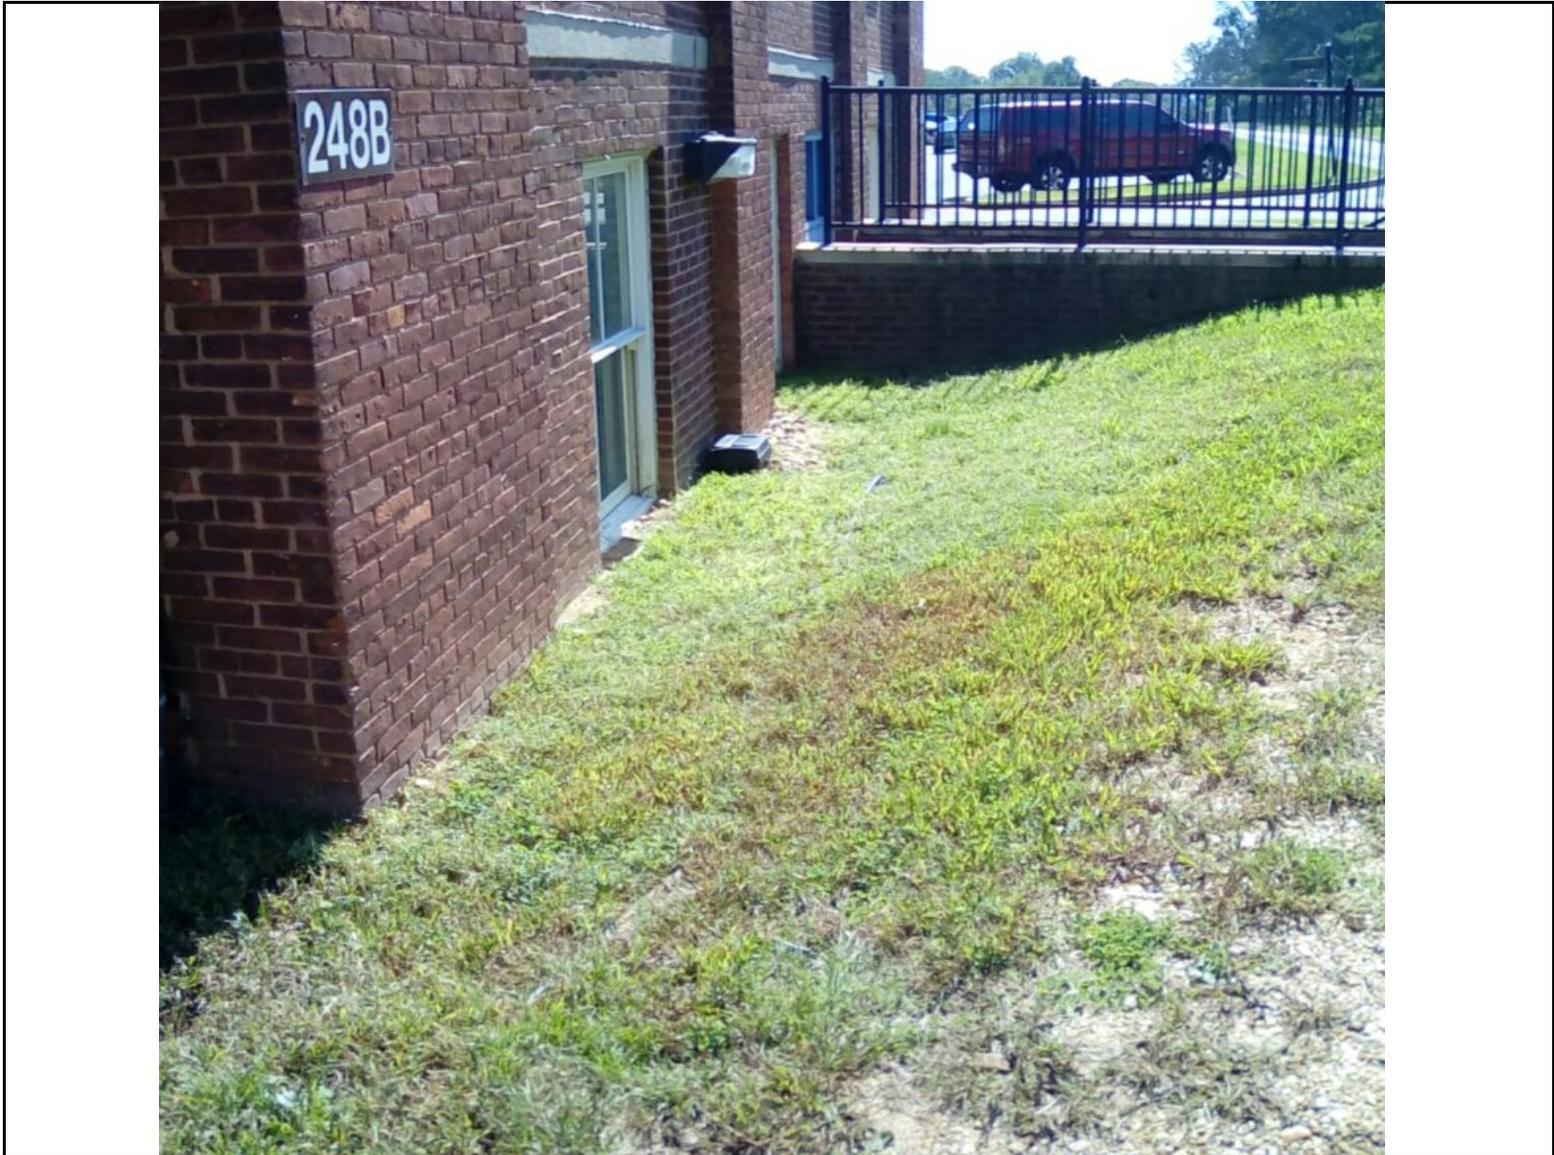
(1) Grade drains steeply toward building.

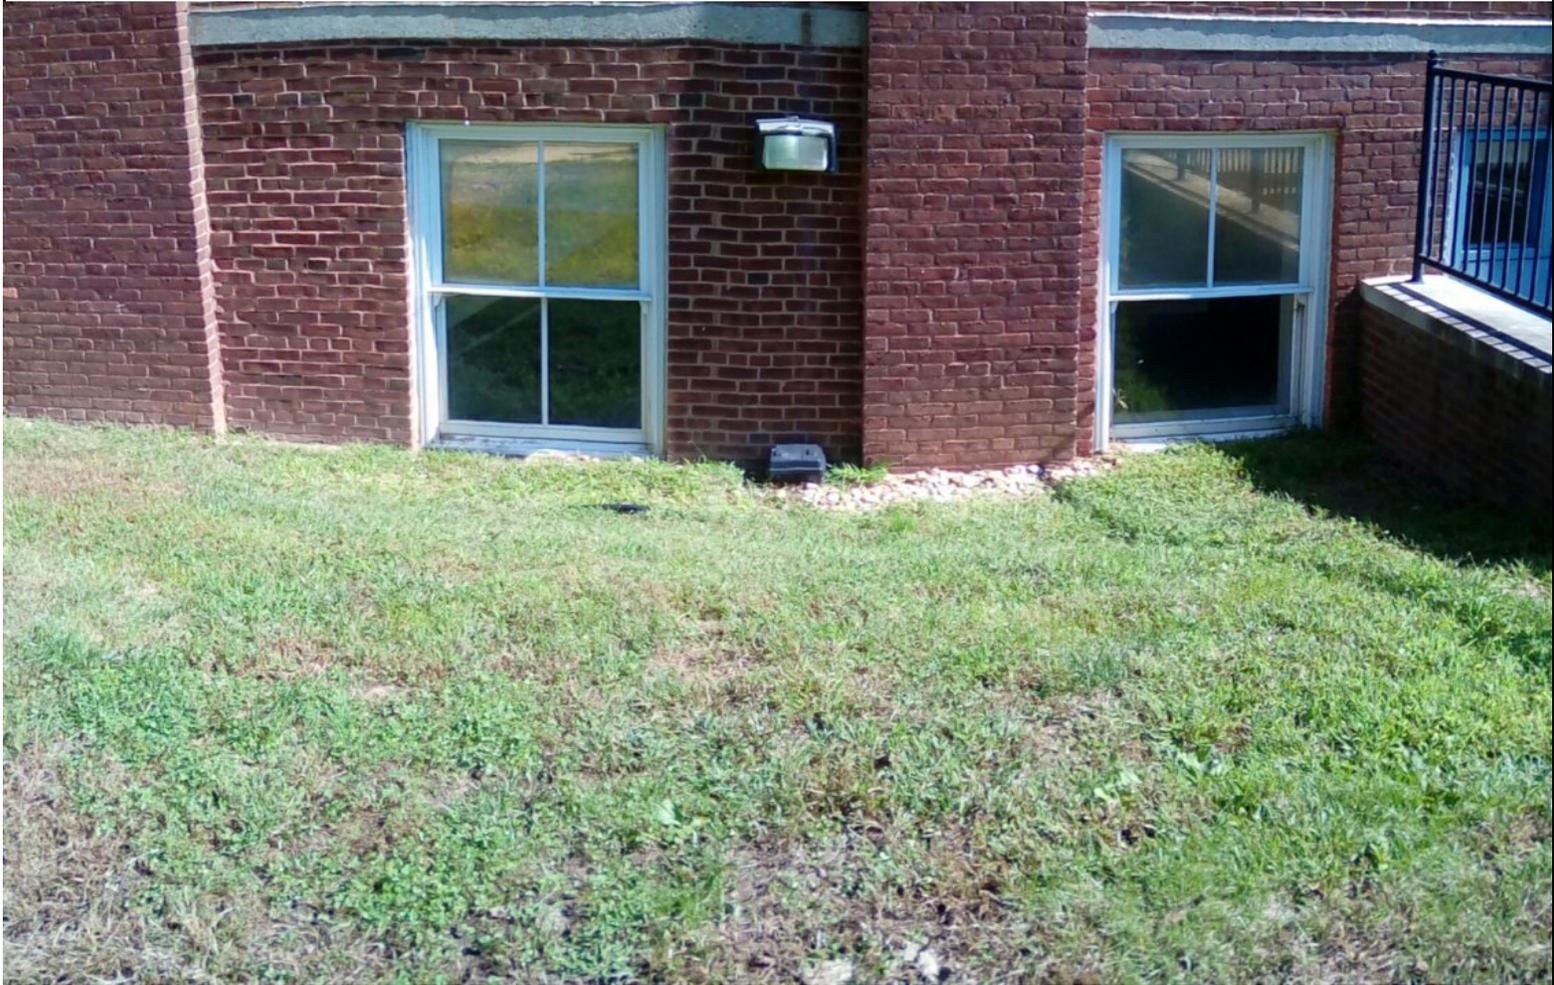
(2) Window sills are at grade or below.

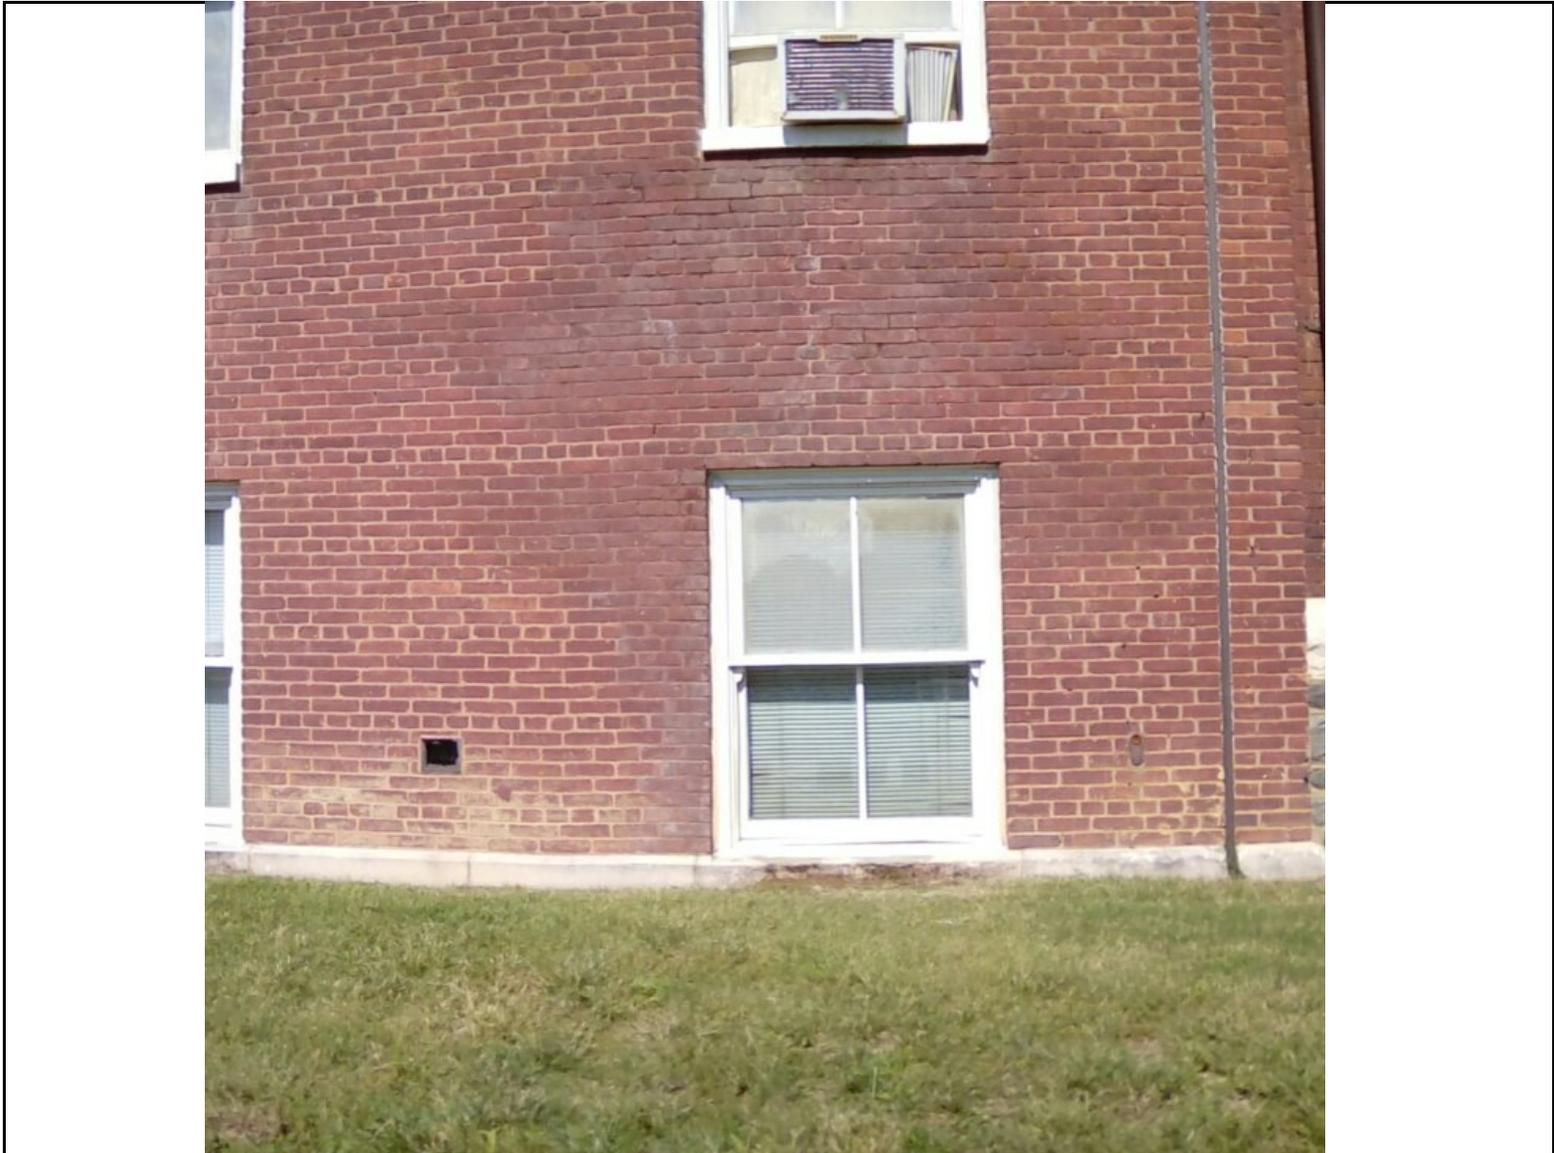
- (3) Window air conditioner is causing damage to wall and window sills below.

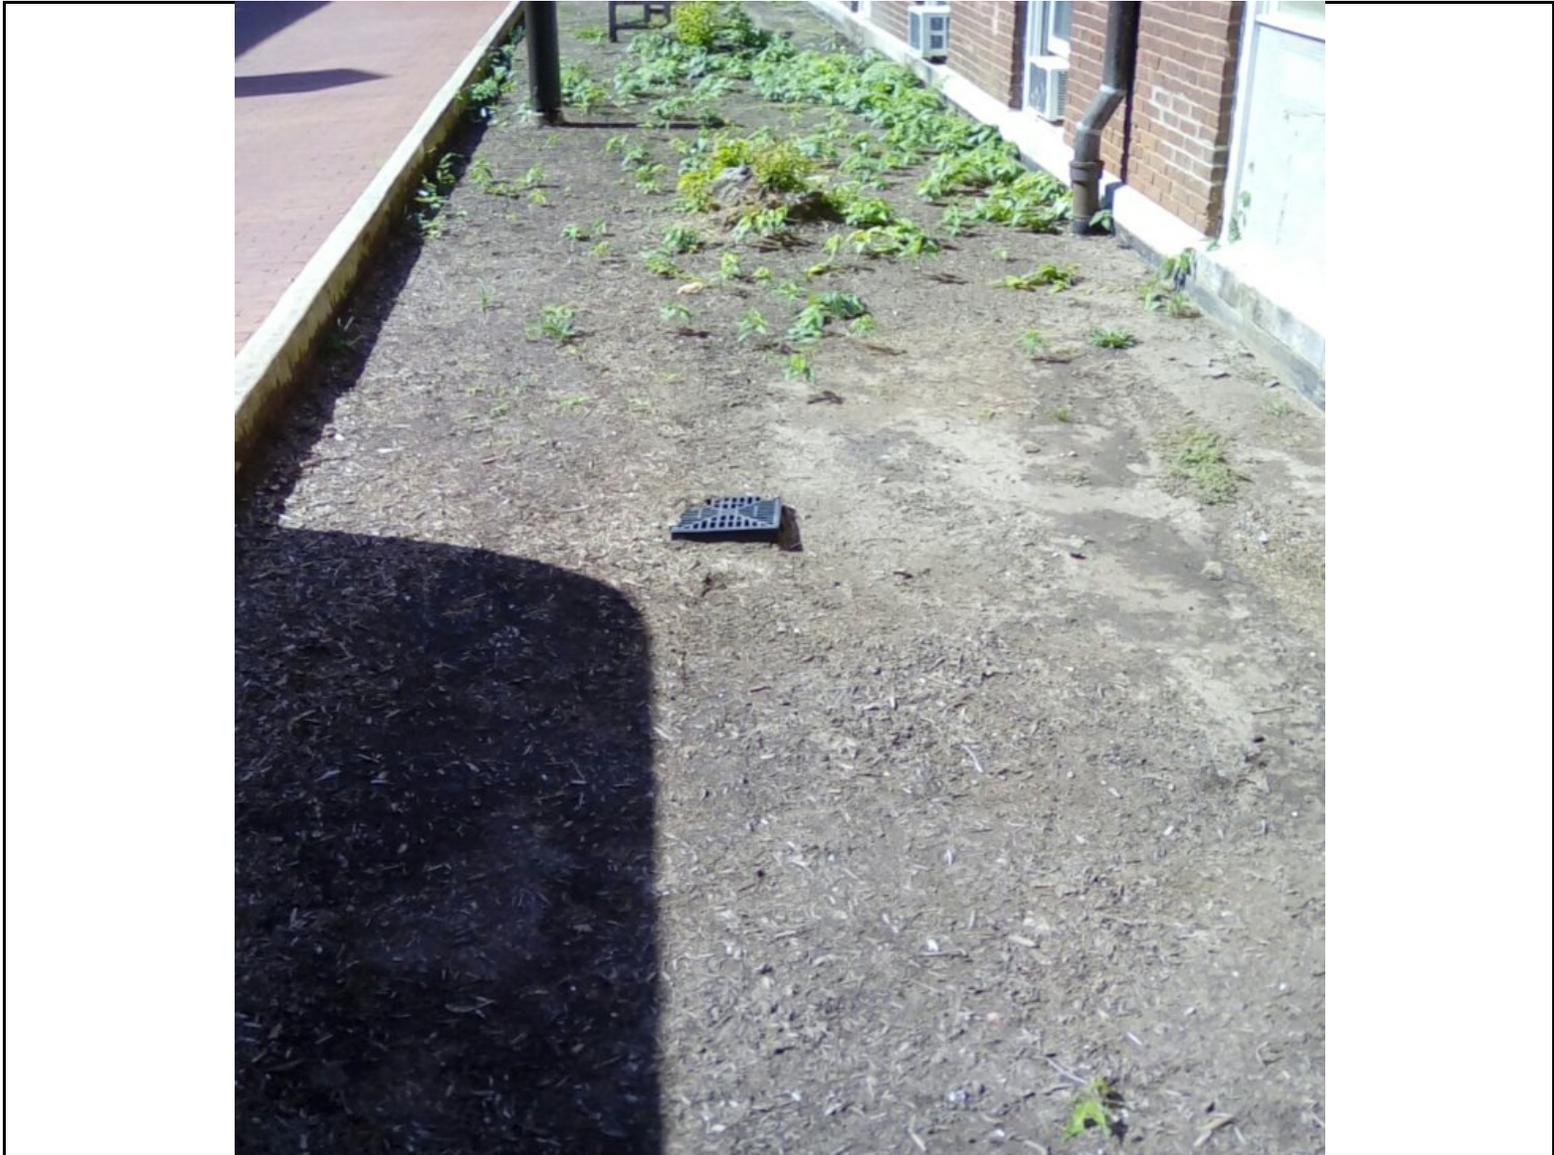
(4) Area drains are 2" above grade

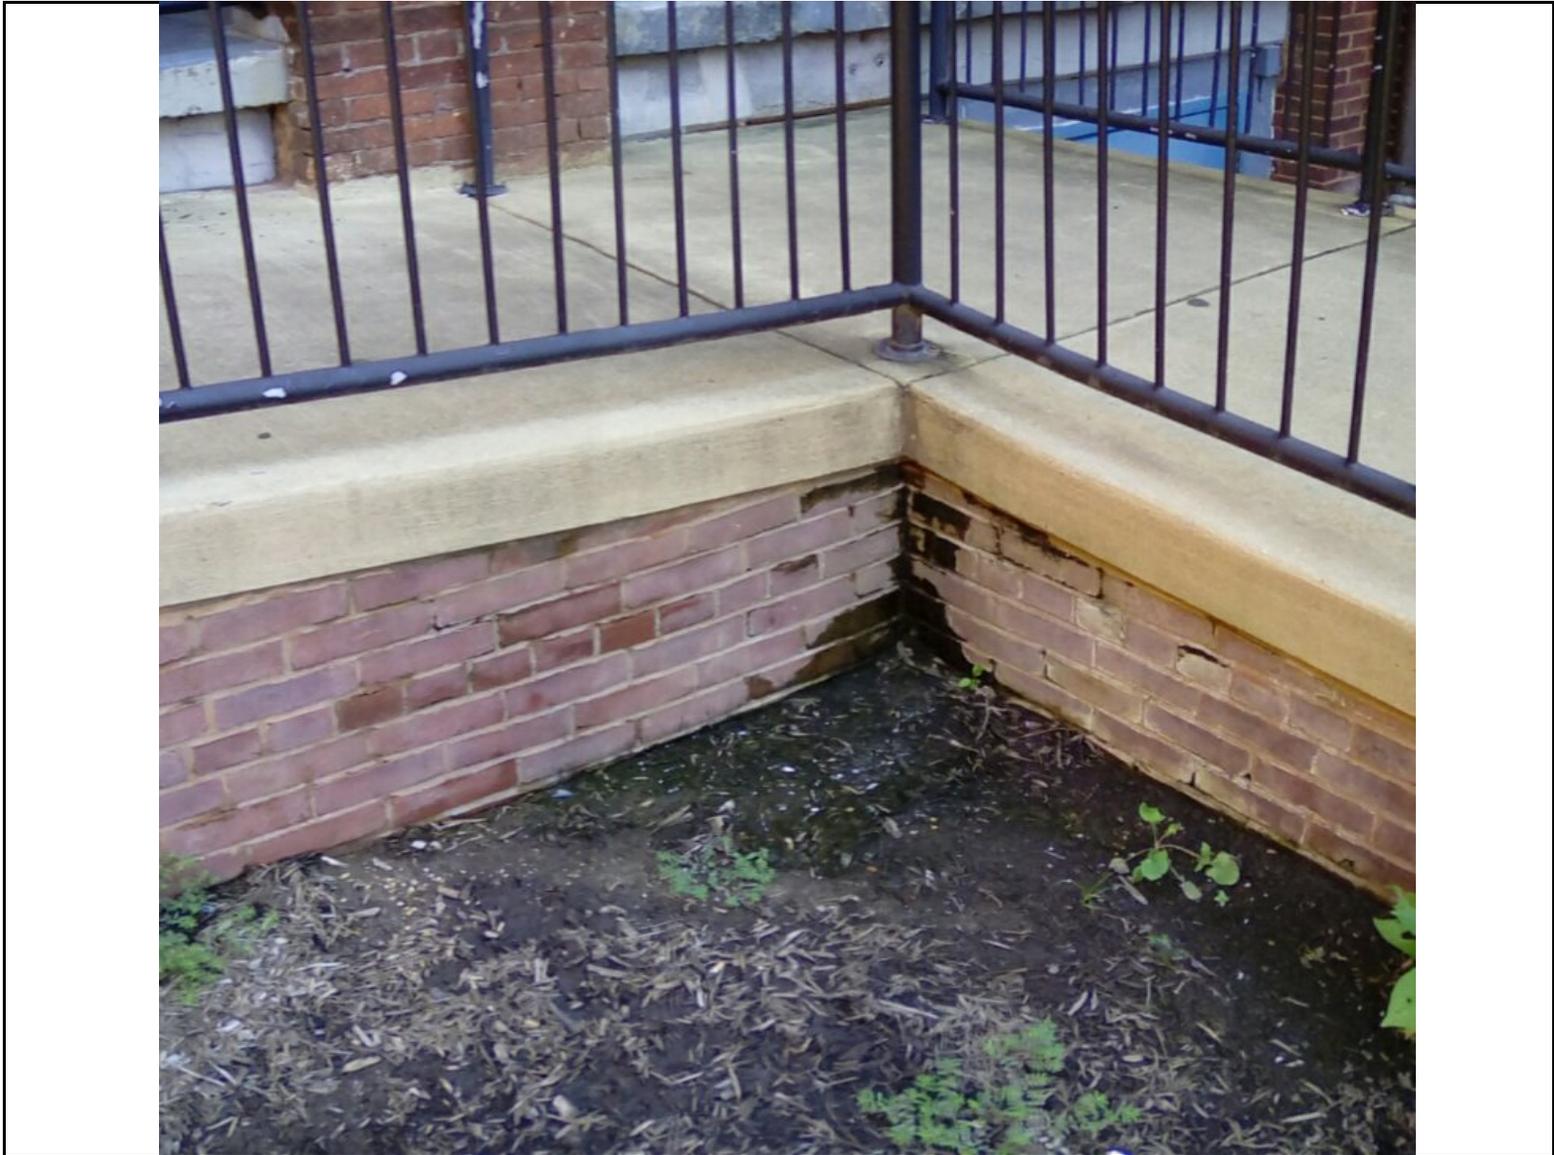
(5) Water damage due to drainage patterns

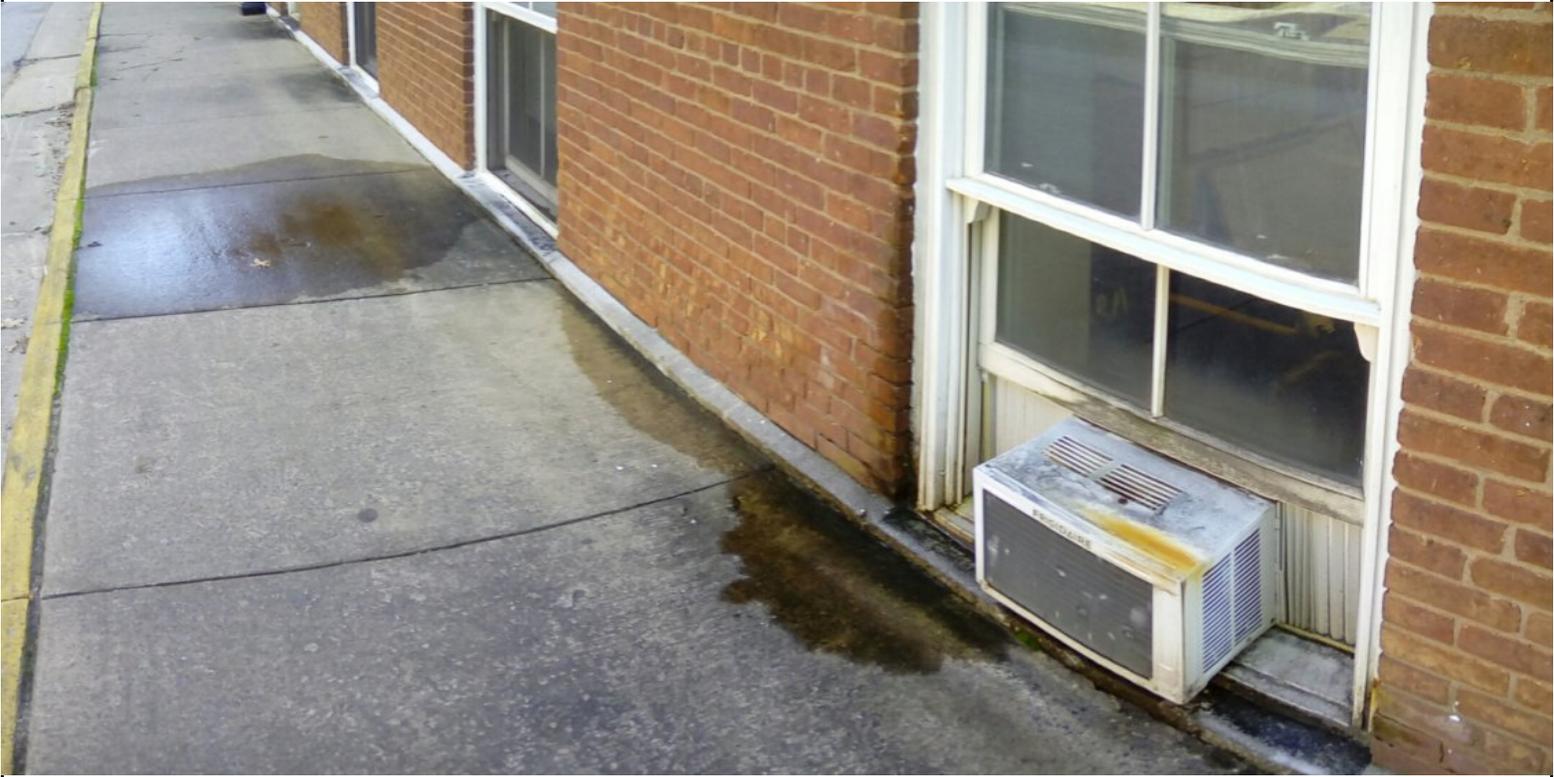
- (6) The seam where the building wall meet the concrete walk needs to be re-sealed.

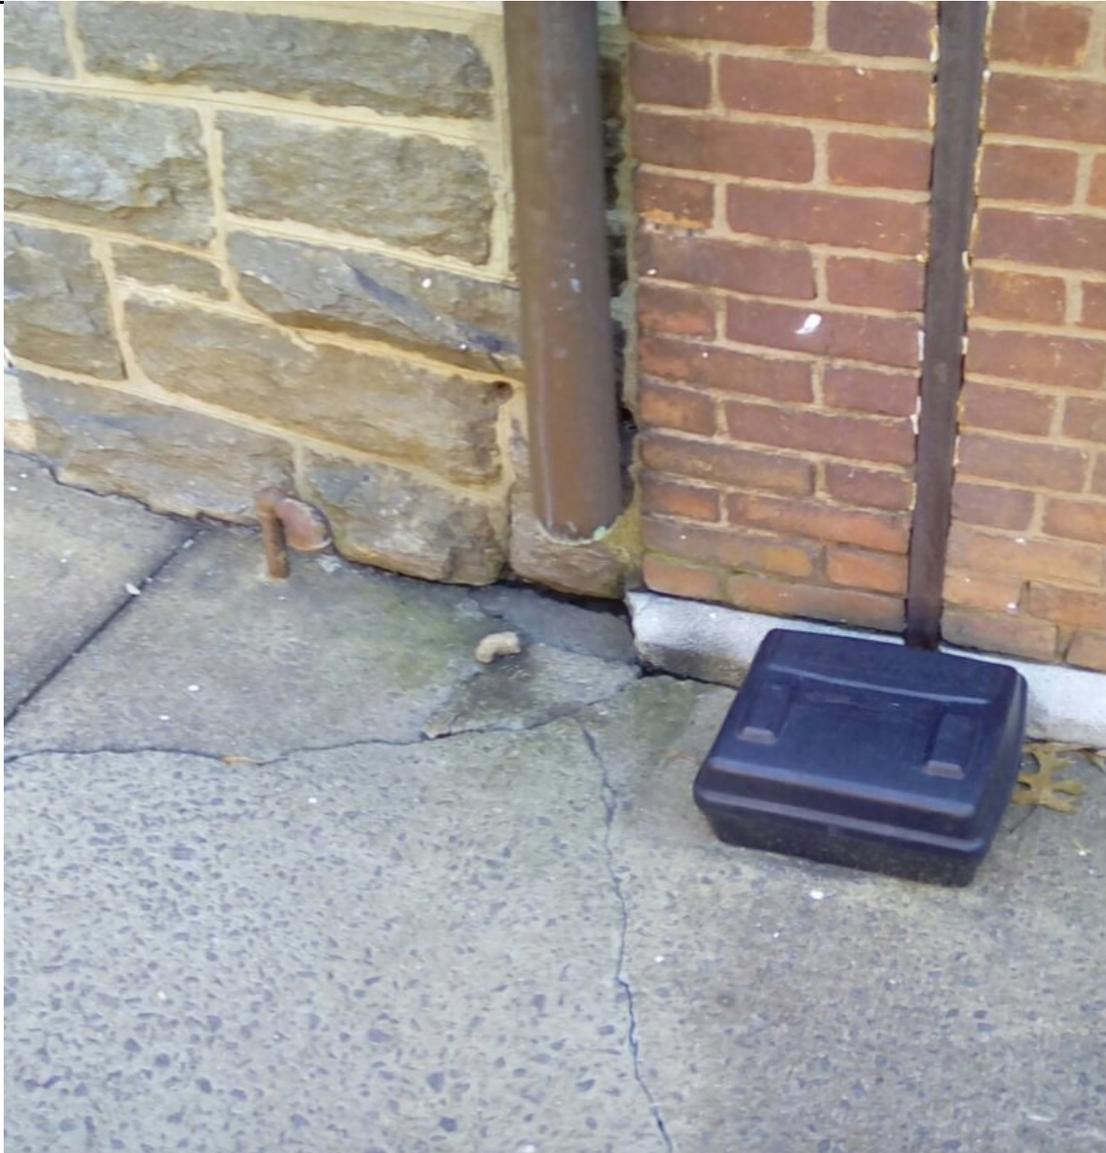
- (7) Roof drain outfalls directly to sidewalk with no 45 degree connection.

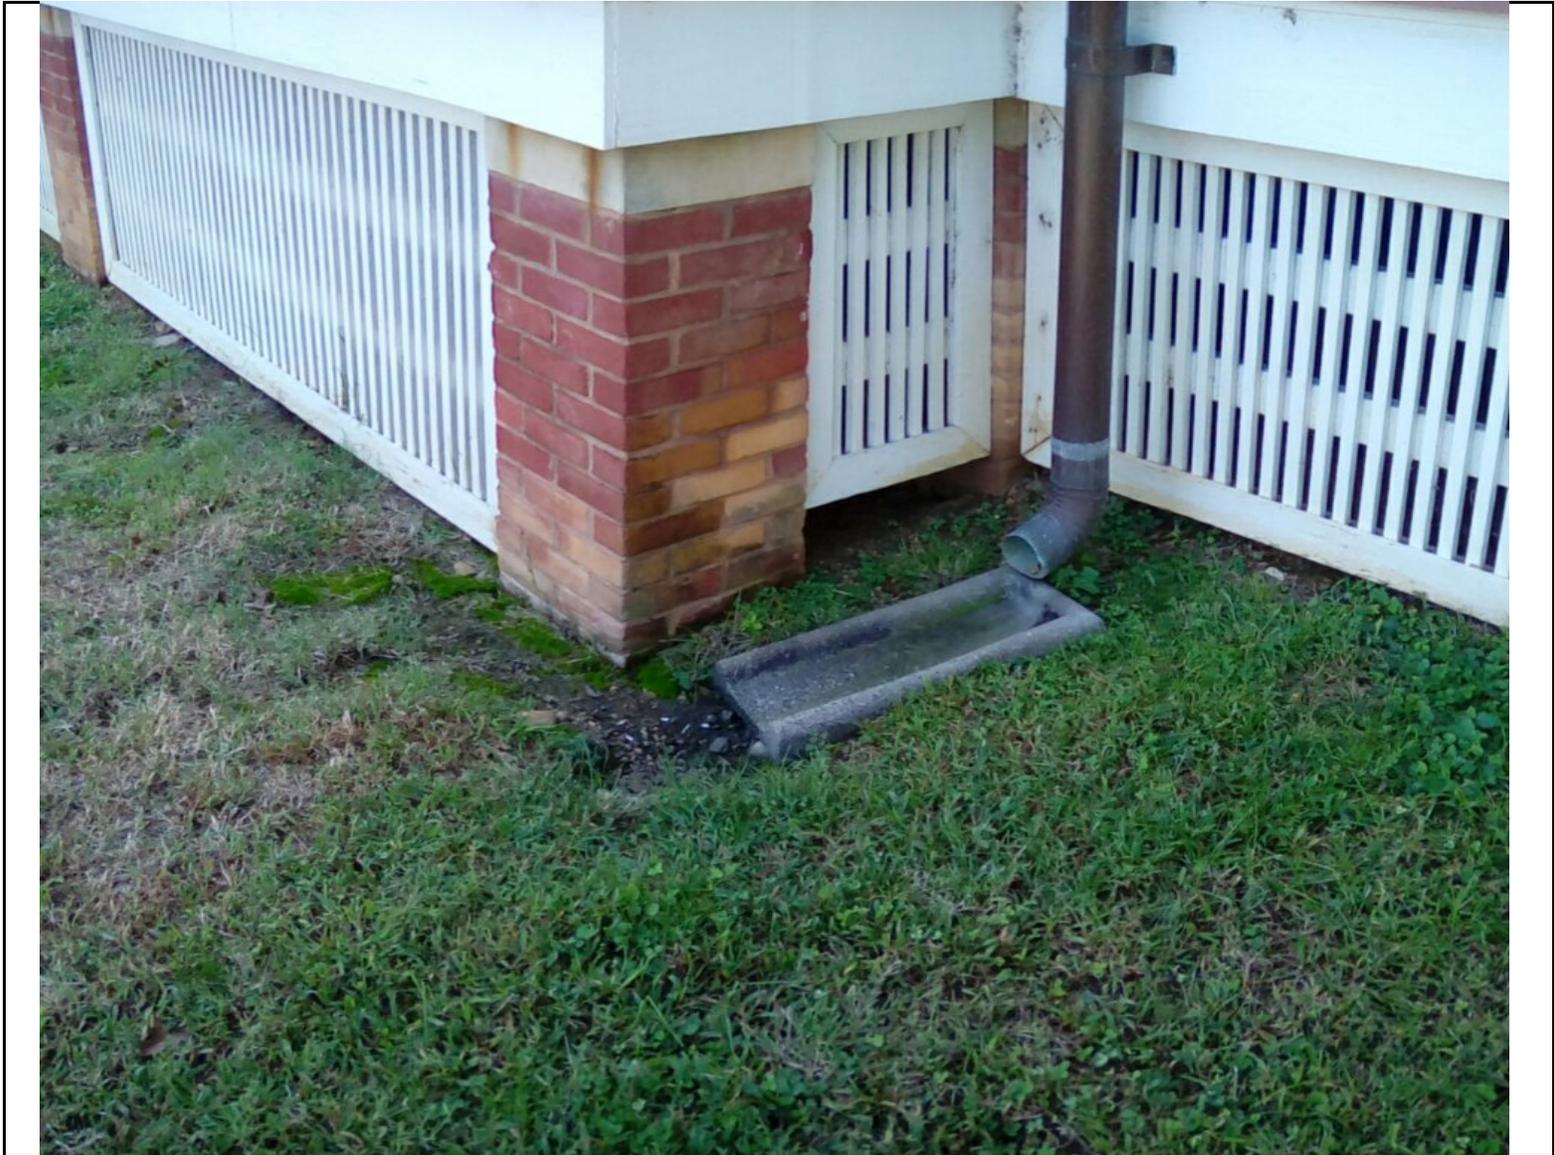
(9) Roof drain splash block slopes toward the building.
