US Army Corps
of Engineers
Baltimore District

ENVIRONMENTAL HEALTH FACILITY ASSESSMENT

Ft. Myer Building 248

Joint Base Myer-Henderson Hall, VA

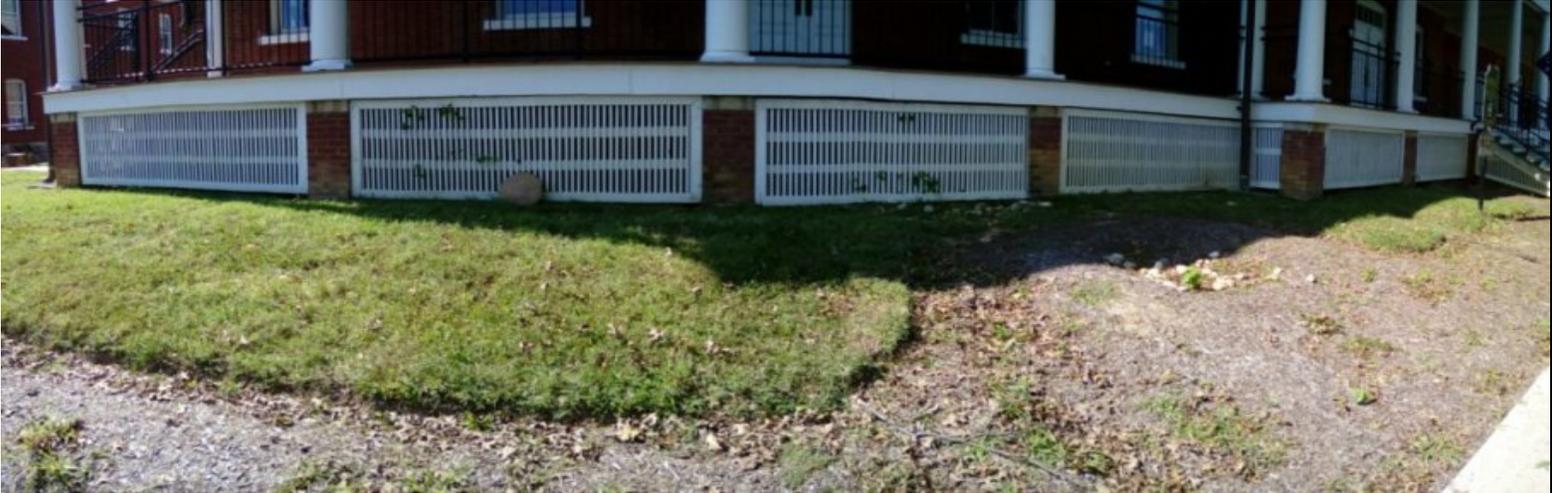
(8) Grading problem keeps water against the building.

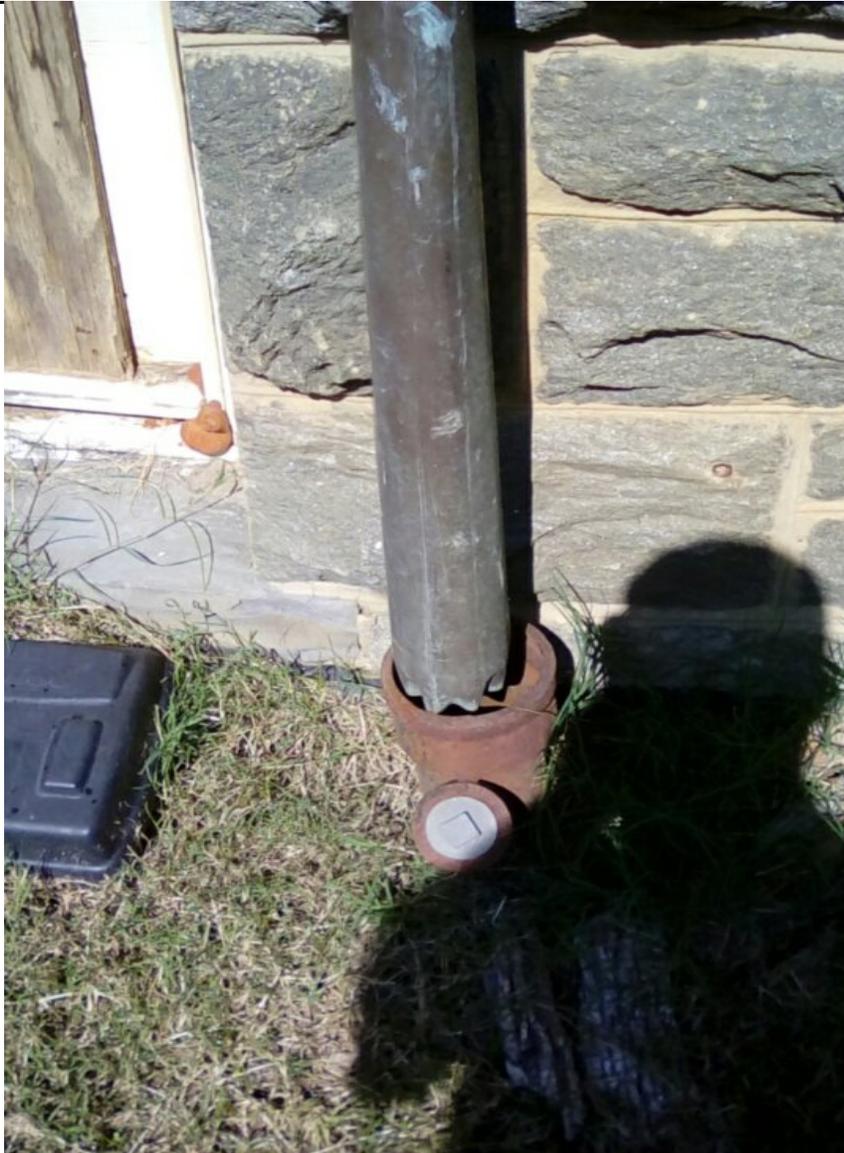
- (10) Roof drain downspouts do not go far enough down into the underdrain pipe.
